# COMBINED REMEDIAL INVESTIGATION/FINAL ACT 2 REPORT

For the 2019 Naphtha Release Area

**FORMER PHILADELPHIA ENERGY  
SOLUTIONS REFINERY  
3144 West Passyunk Avenue, Philadelphia, PA  
Passyunk Township, Philadelphia County**

**June 2021  
220146201**

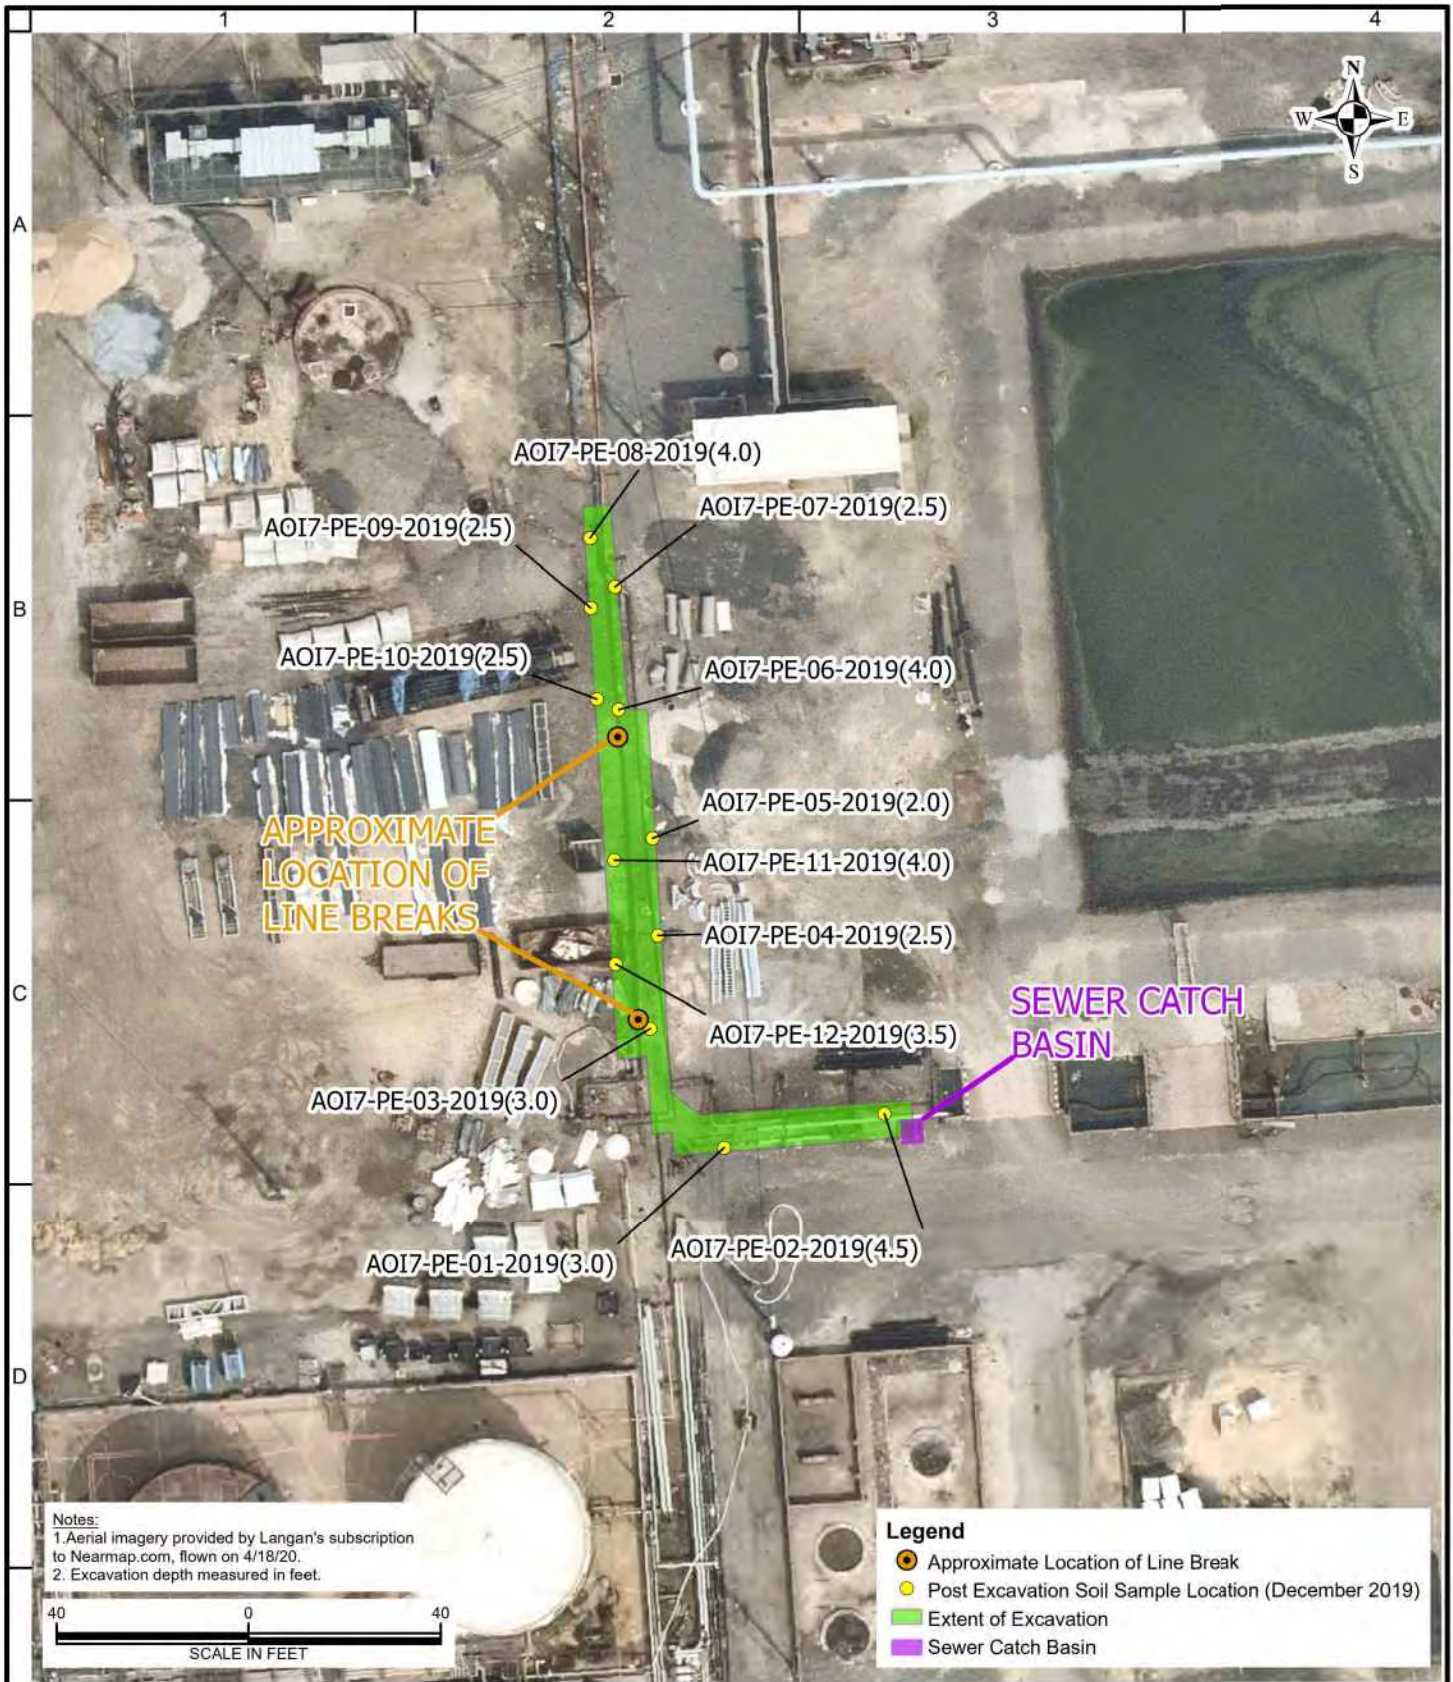
Figure  
**3**

The released product was contained by site topography and existing drainage features. The product was observed by Stantec Consulting Services, Inc. (Stantec) to flow to the south along surface grading, parallel to the piping run and then to the east toward a sewer catch basin (Stantec, March 2020). The area of impacted soil is shown shaded in green on Figure 3.

In March 2019, Stantec mobilized to the site to perform a remedial investigation of the area around the naphtha discharge. The area shaded in green on Figure 3 shows the extent of observed staining of soil following the discharge. Stantec collected 20 soil samples from 20 soil borings (AOI7-BH-01 through AOI7-BH-20) around the visible area of the release in order to confirm and differentiate the extent of the potential impact from the 2019 naphtha release from known pre-existing petroleum impacts that stem from the history of petroleum storage at the former PES Refinery. As reported in their November 13, 2020 summary, Stantec hand-augured borings to 0.5 to 3 ft bgs, above the shallow water table. Soil boring locations are presented on Figure 4. Unsaturated soil samples for laboratory analysis were collected from the 0.5 to 2 ft-interval and analyzed for the PADEP unleaded gasoline short list parameters. Soil samples were submitted to Pennsylvania-certified Eurofins Lancaster Laboratories Environmental in Lancaster, Pennsylvania for analysis of VOCs by EPA SW-846 Method 8260B.

Between November 25 and December 12, 2019, PES conducted an excavation of the soils impacted by the release of light naphtha. A total of 376.9 tons of soil were removed and disposed offsite at Clean Earth of New Castle, Delaware, a licensed treatment, storage and disposal facility. Manifests are included in Appendix C. Following post-excavation soil sampling, the excavation was backfilled with soil sourced from Lot 17 (at the refinery) that was eligible for reuse according to the May 23, 2013 *Onsite Soil Reuse Plan*. This document was filed with the PADEP in 2013 and was established as the protocol for soil reuse at the time of the remediation described above.

As documented in a November 13, 2020, report prepared by Stantec (Appendix A), during excavation activities, the field team observed evidence of additional historical petroleum impacts in the subsurface which were not related to the 2019 naphtha release. Four buried drums were encountered at approximately 3 to 4 feet below ground surface (ft bgs) near the central area of the excavation. The drums were observed to be in a deteriorated condition, and an unknown viscous product was observed. The drums and surrounding soil were removed by Evergreen. After the drums were removed, the excavation and post-excavation samples to address the naphtha release were completed by Stantec. The area of excavation is shown on Figure 3.

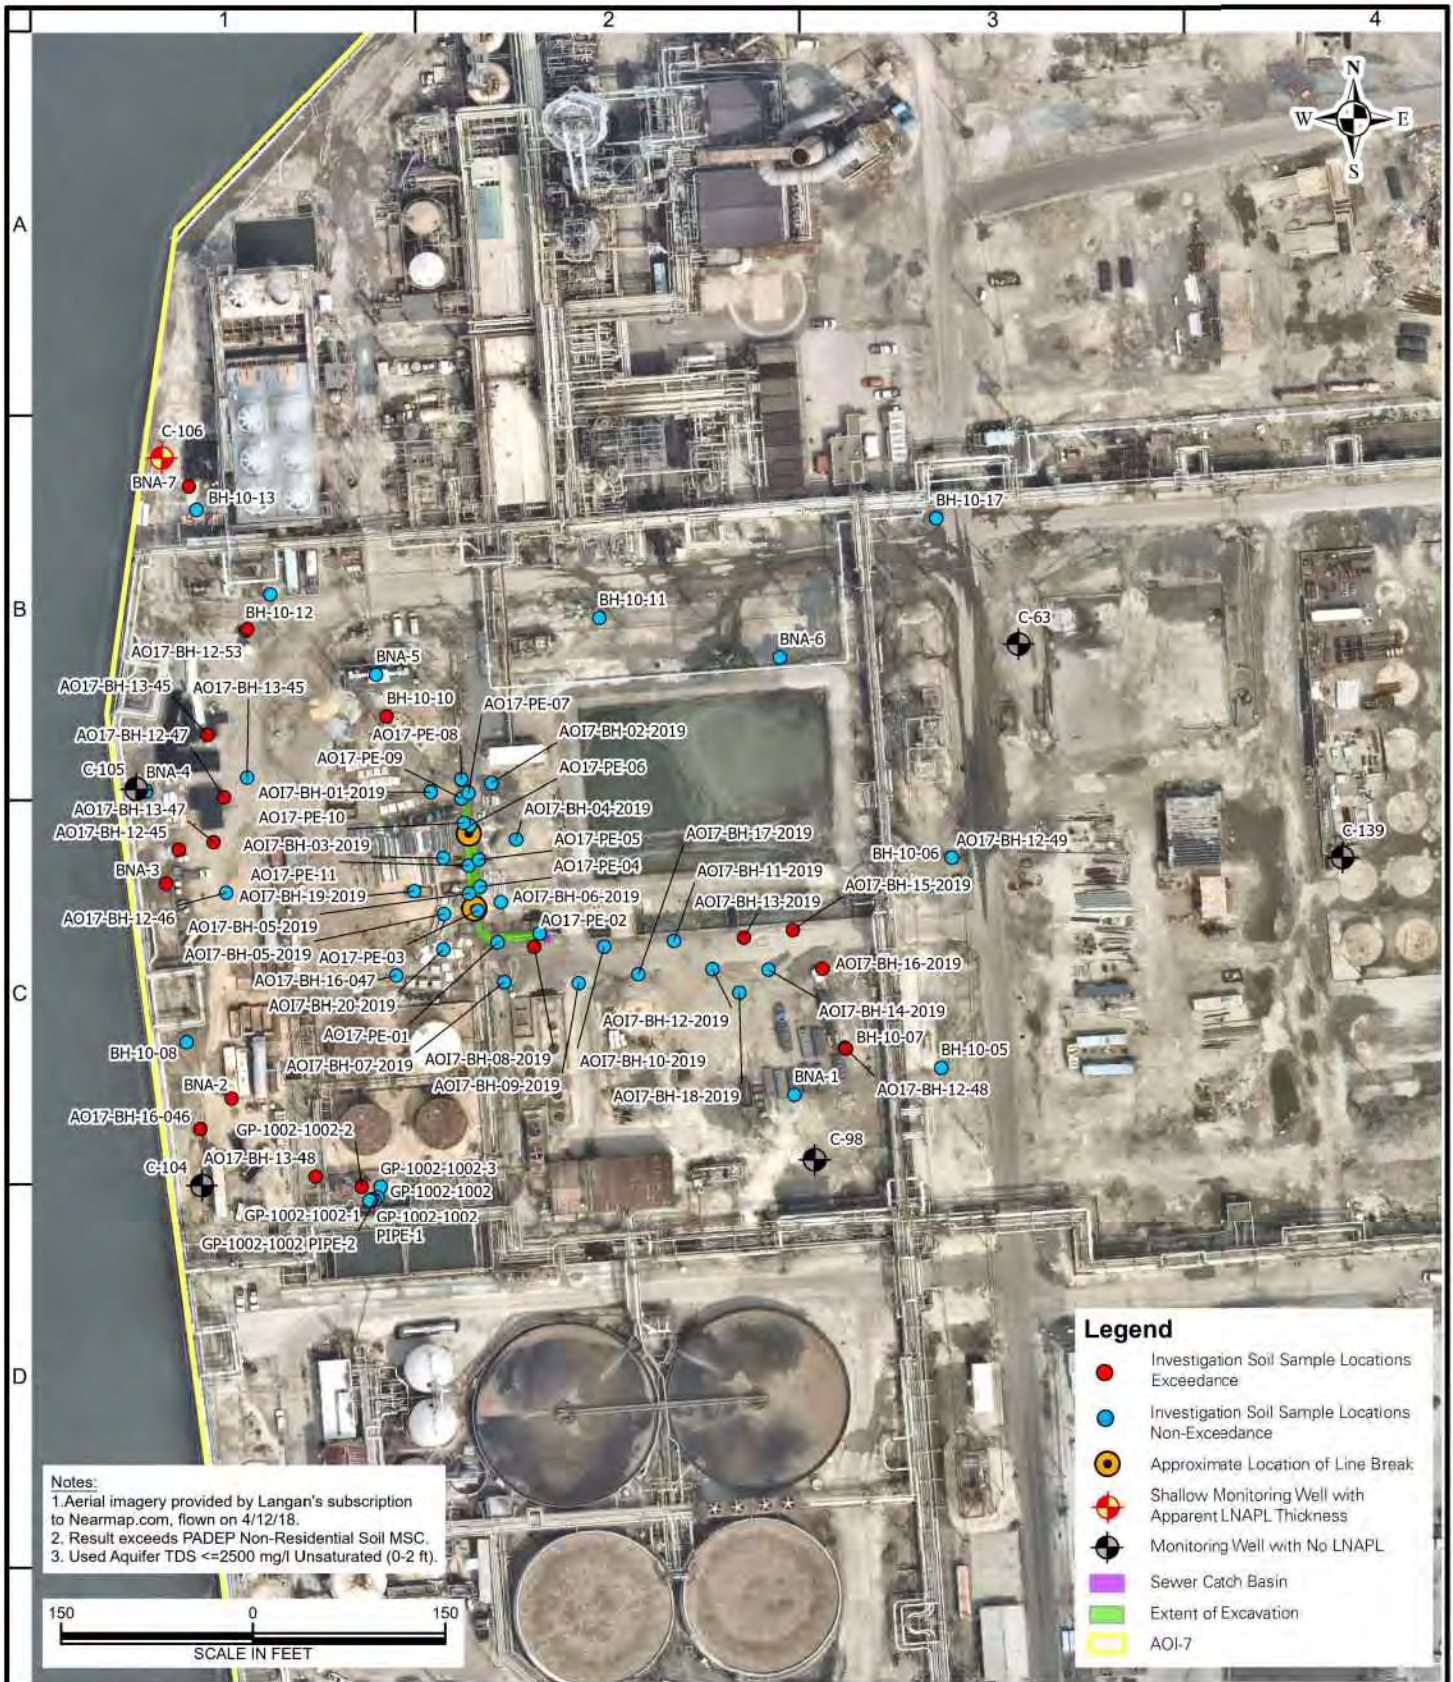
Figure 4

Project No. 220146201  
 Date 4/6/2021  
 Scale 1" = 60'  
 Drawn By KMB  
 Submission Date

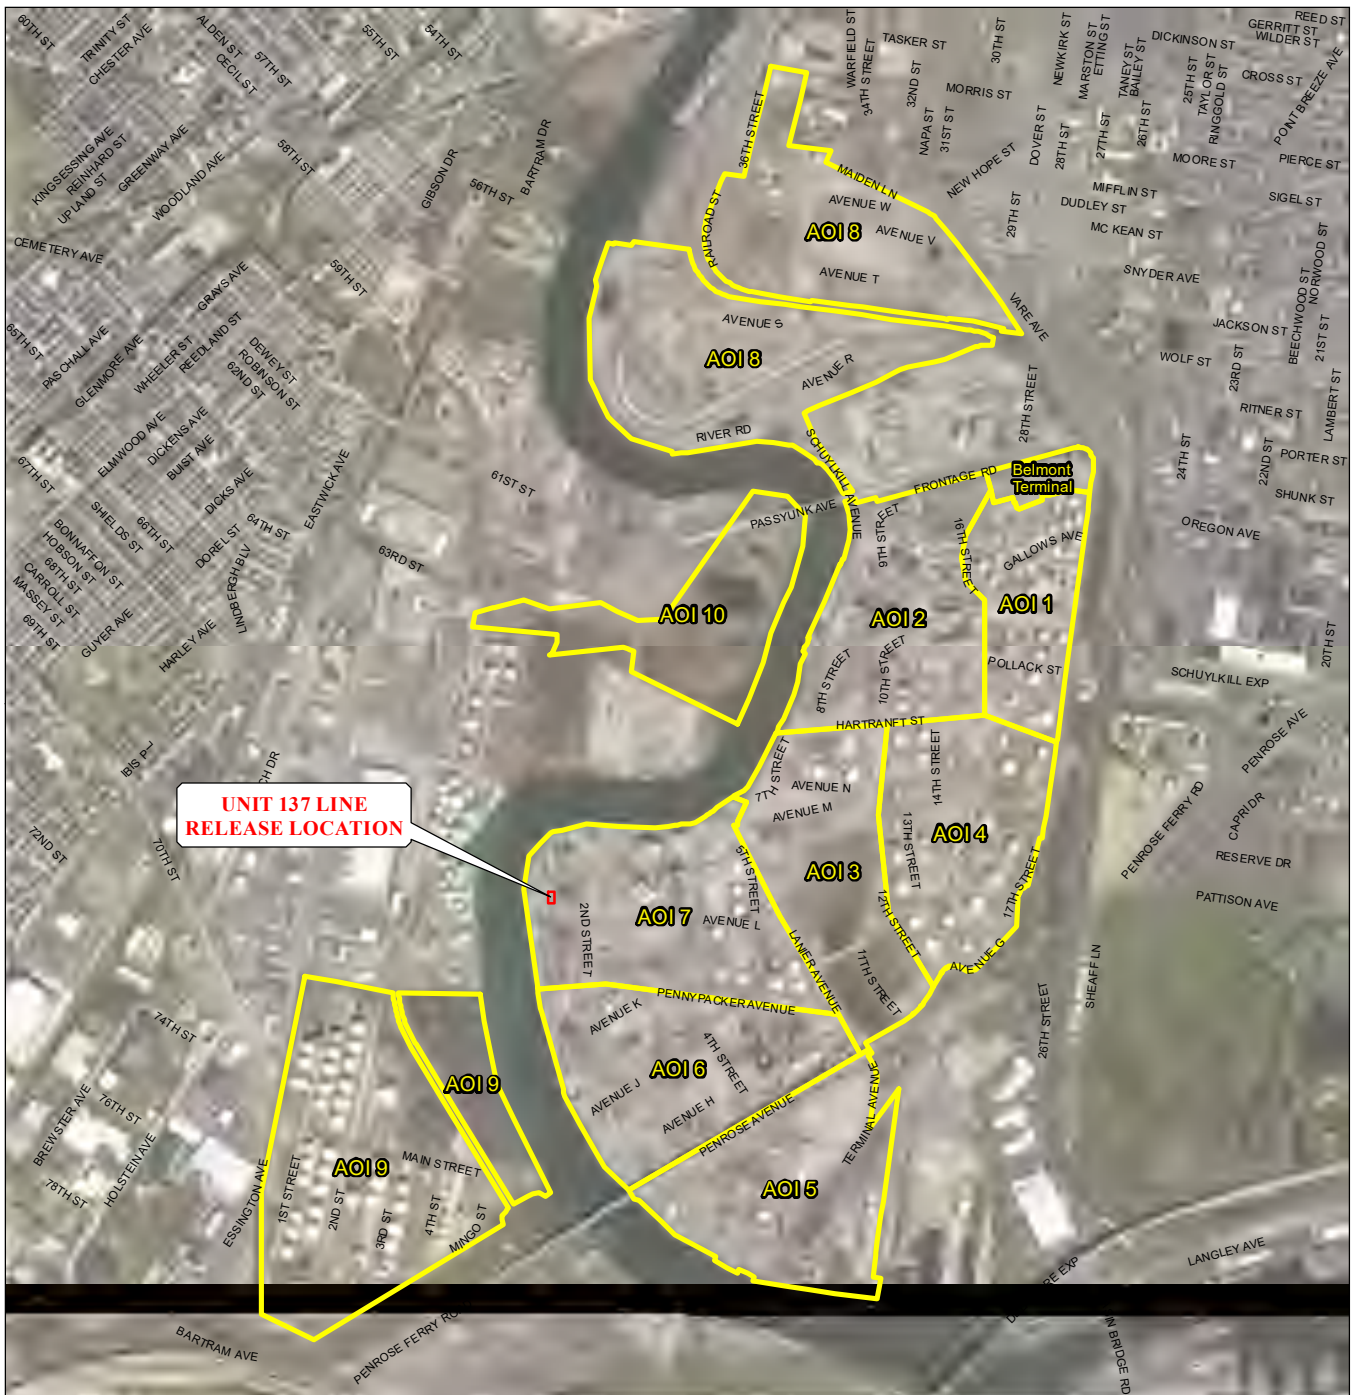
Figure No. 1  
 Title

**UNIT 137 LINE  
RELEASE LOCATION**

In February 2019, PES restarted Unit 137 and when the aboveground product line was charged, light naphtha was released out of two undiscovered defects. The location of the release with respect to the PES Complex is shown on **Figure 1**, and the locations of the line breaks are shown on **Figure 2**. This release area is generally referred to as the 136 area since this is the location of the former Unit 136. An estimated 53,000 gallons of product identified as light naphtha was released to the ground surface and was observed generally to flow along surface grading in a southerly direction, parallel to the piping run. The surface flow was observed to then dogleg to the east toward a sewer catch basin. PES performed immediate interim remedial actions to mitigate potential impacts from the release which included removal of liquids from the storm sewer and culvert via vacuum truck and removal of water/product mixture from test pits advanced along the compromised product line. The damaged section of product line was replaced with new piping.

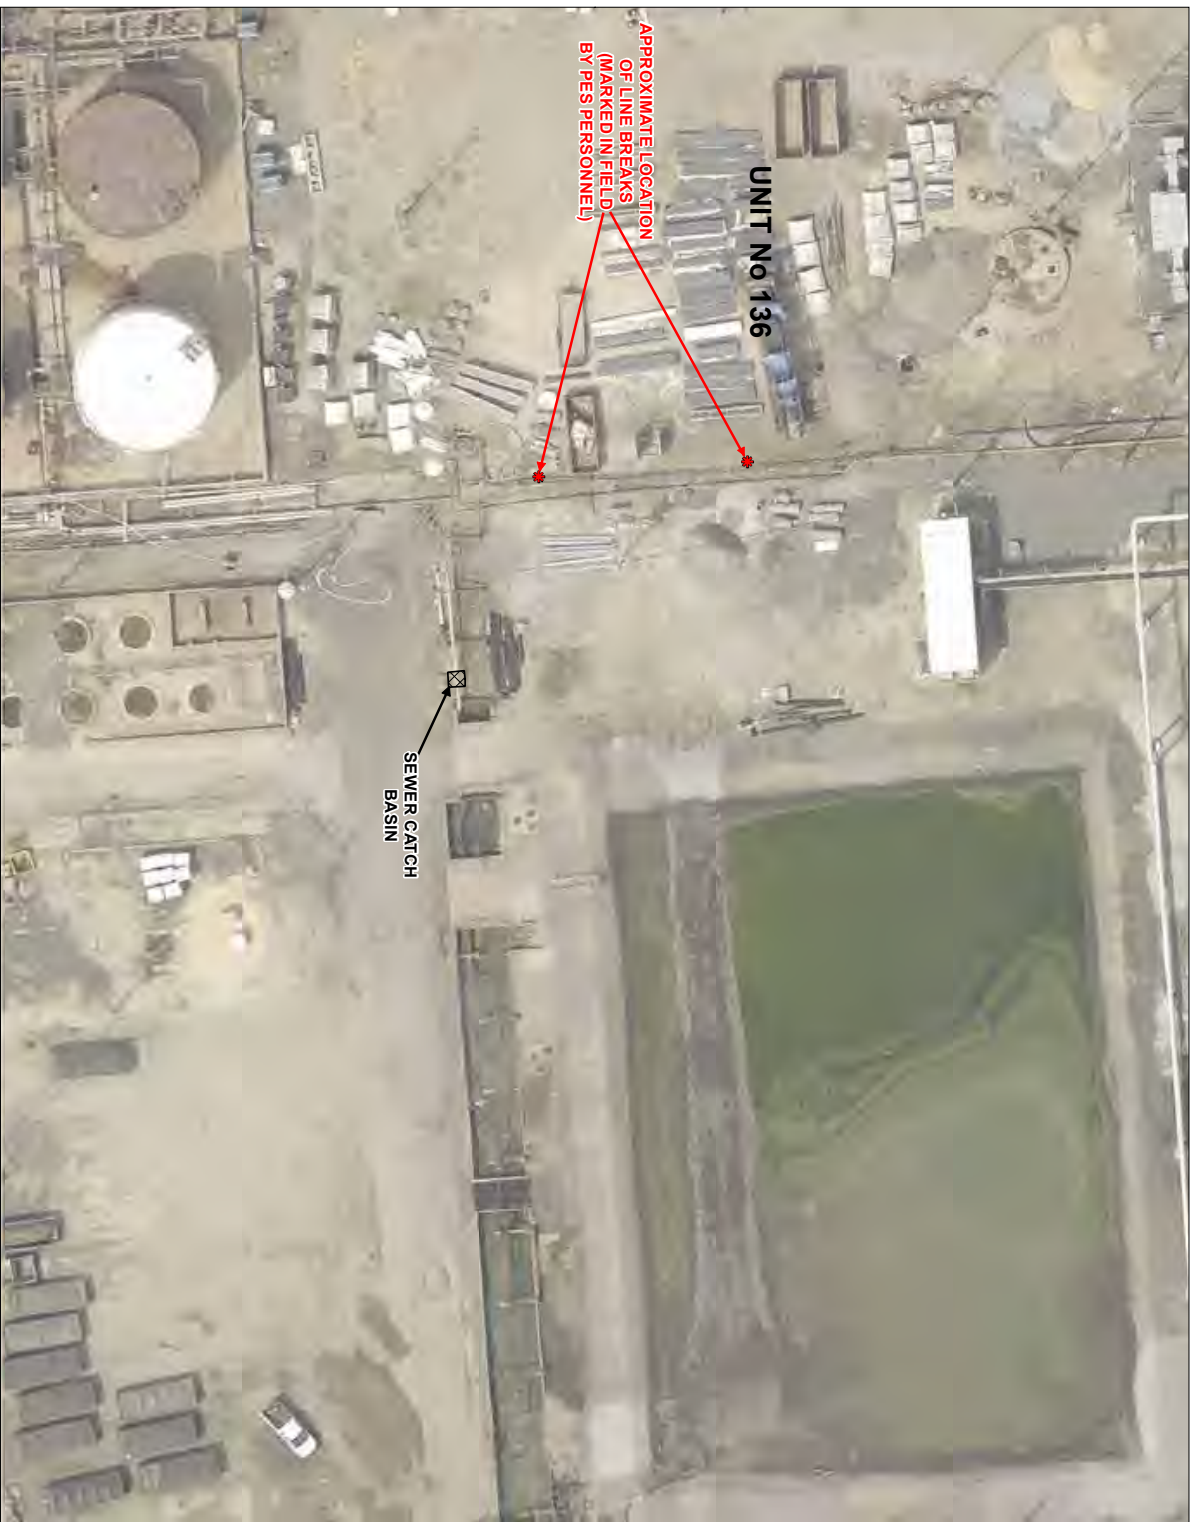
Figure No. **2**  
**UNIT 137 LINE RELEASE IN THE AREA OF FORMER 136 UNIT**

The 2019 PES release occurred from a product line to the south of Unit 137 in the area of the former Unit 136. Representations of the historic structures are shown on **Figure 3**. Aerial imagery indicates that the historic crude unit was constructed prior to 1950 and demolished between 1999 and 2002. The foundation observed in association with LNAPL seepage in the northeastern portion of the excavation may be associated with the round and oval structures immediately to the east. The buried drums were located in the central area of the Unit 136 infrastructure. The former hazardous waste tanks and sludge basins were located to the southwest, outside of the Unit 136 area.
